Test results HDSP9632 / SN 23026526

The HDSP9632 with serial number 23026526 was sent to IMM by RME Trading 8th April 2016.

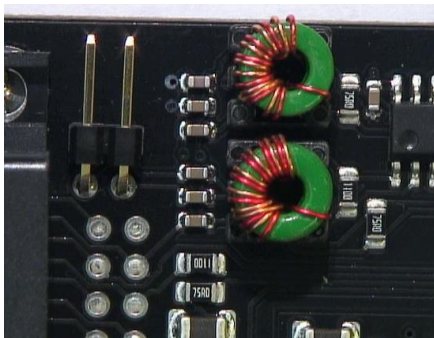
original

Transformer bifilar

At first sight you can see the poor quality of the bifilar transformers. The bifilar winding isn't processed as perfect as used by IMM. These transformers wouldn't pass our quality control.

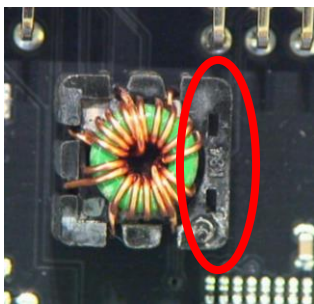
original

Transformer 06 capped

Also this transformer isn't the type used by IMM. A special characteristic of our part is the unnotched base on the right side for eliminating any mistakes in mounting. The transformer of the forged unit has a notch on this side.

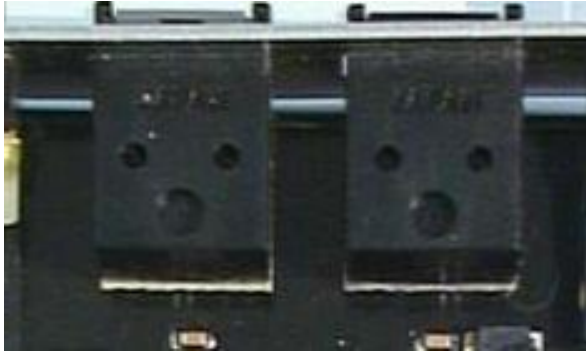
ADAT-connector

The used ADAT-connectors weren't used in our production at this time because of a proclamation of the 25Mbit-type. This is the reason why at the moment of production of the forged unit (according to the date code of the PCB) IMM always used the type of Lih Shen.

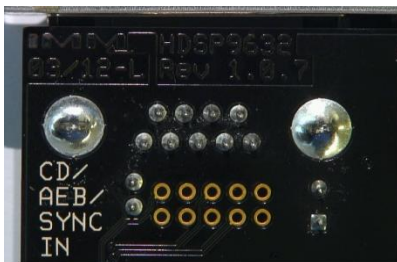
Evaluation soldering process THD

The PCBs of HDSP9632 are wave soldered. During this process all holes below the 9pole D-SUB-socket will not be masked so that they will be filled with tin. The forged unit has unfilled holes.

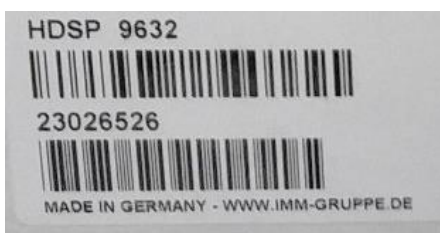
Cardboard

The label on the cardboard doesn't comply to any of the used labels of IMM. The product designation is written as bar code (never written at IMM labels) and below is the serial number as bar code.

The label print can only be created on basis of our ERP-system. That's the reason why it can't be printed from our ERP-system, because this serial number refers to a HDSPe RayDat additional board.
